**AN ARCHAEOLOGICAL SURVEY OF
SUNDANCE RANCH
NORTHERN BEXAR COUNTY, TEXAS**

**Submitted to
Frost Geosciences
Helotes, Texas**

**Report 55
Abasolo Archaeological Consultants
San Antonio, Texas
2007**

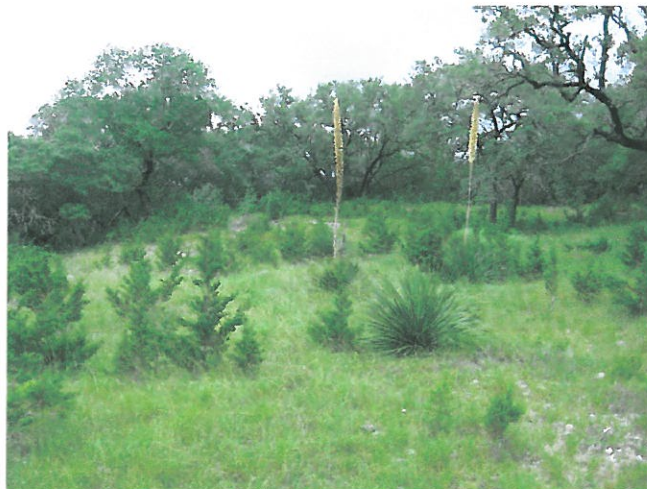
Figure 2. View of upland slope west of Pecan Creek.

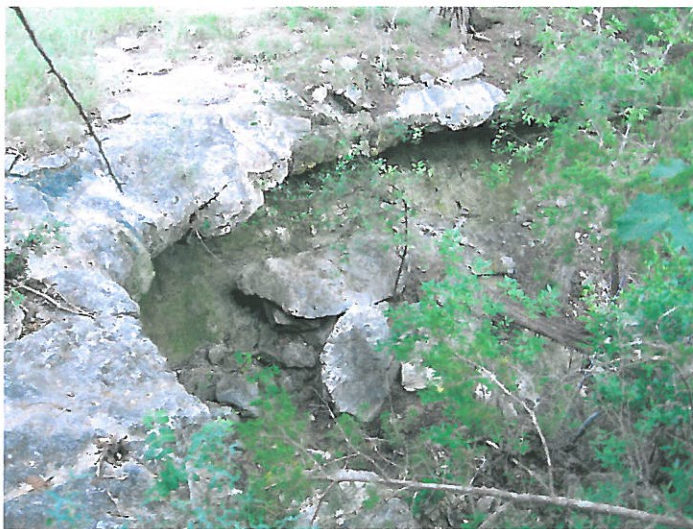
Figure 3. Rock overhang at the head of a small western drainage into Pecan Creek. No evidence of human occupation was present.

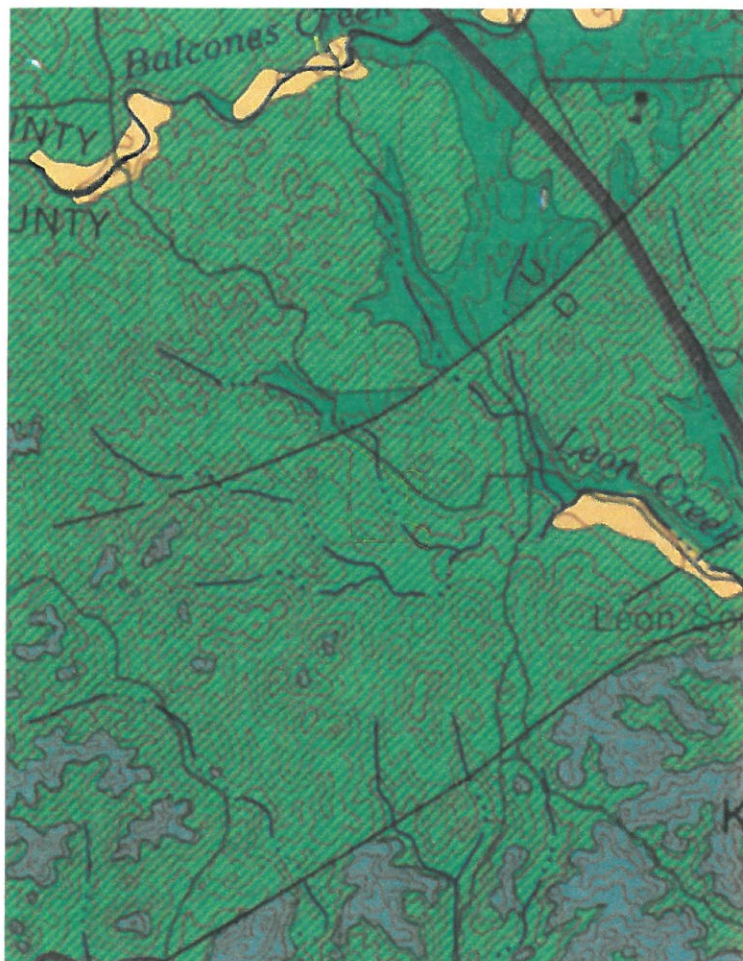
Figure 4. Geological map of the area of Sundance Development. Map provided by Frost GeoSciences.

The Sundance Ranch development is in the Balcones Canyonlands and is drained by Pecan Creek, a tributary of Leon Creek (Figs. 1-4). The dominant geological formation is the Cretaceous Glen Rose formation (Fig. 4). Topography is hilly formed by the erosion of the Glen Rose that created the creek valley. Valley soils are Krum complex along the west side of the north-south trending creek and Lewisville silty clay (1 to 3 percent slope) on the east side of the creek. Upland soils are Tarrant association gently undulating and Brackett-Tarrant association hilly (Fig. 5) (Taylor et al., 1991).

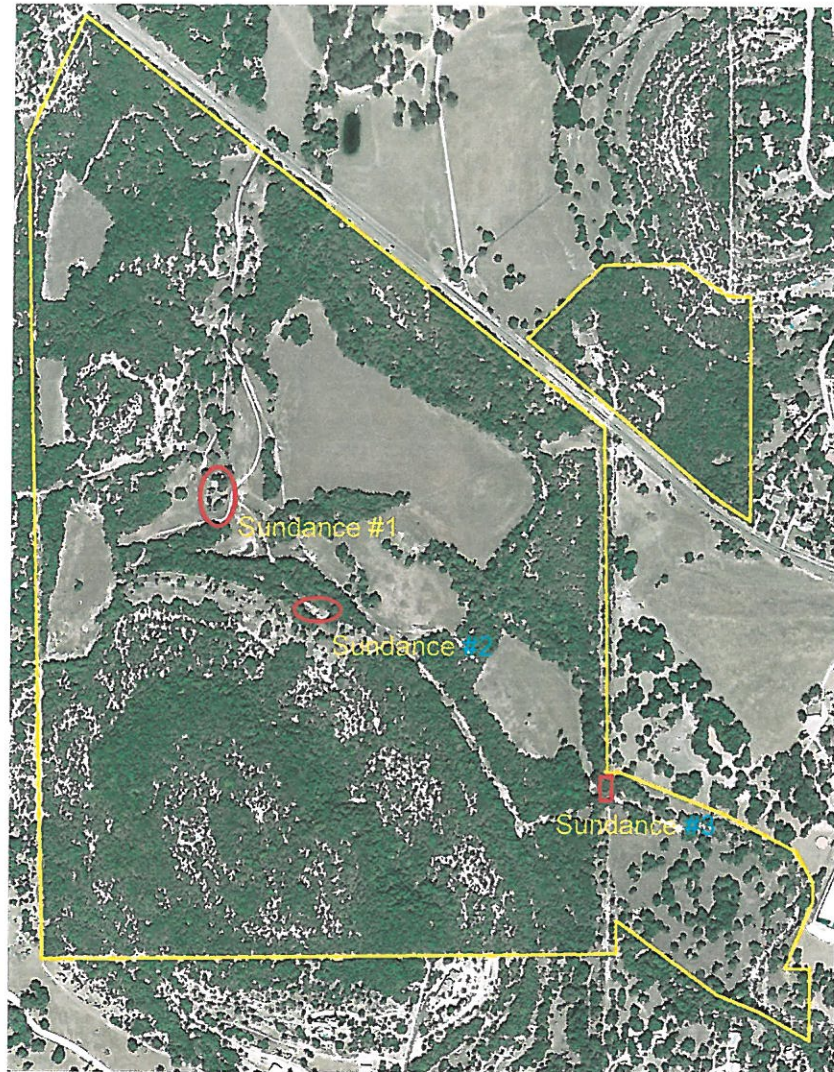
Figure 6. Aerial view of property showing site locations (red circles and rectangle).

The survey identified three archaeological sites (Fig. 6), all historic in nature. The setting and environment are conducive to finding prehistoric sites, particularly burned rock middens and burned rock scatters usually associated with the outskirts of the middens. However, we did not find any such features or identify. Fire-cracked limestone was observed on the east side of the creek, along the creek on the west side near Toutant Beauregard Road, and also on the slopes west of the creek. Some of the fire-cracked rock was probably cultural in nature and some may have been due to brush and grass fires, and land clearing. The only chipped stone artifacts were three pieces of chert (flint) and a possible limestone hammerstone/mano (Fig. 27) on the east side of the creek in the Lewisville soils association. Perhaps the absence of flowing springs and exposures of natural chert may have contributed to the absence of prehistoric sites. Descriptions of the historic sites are provided below.

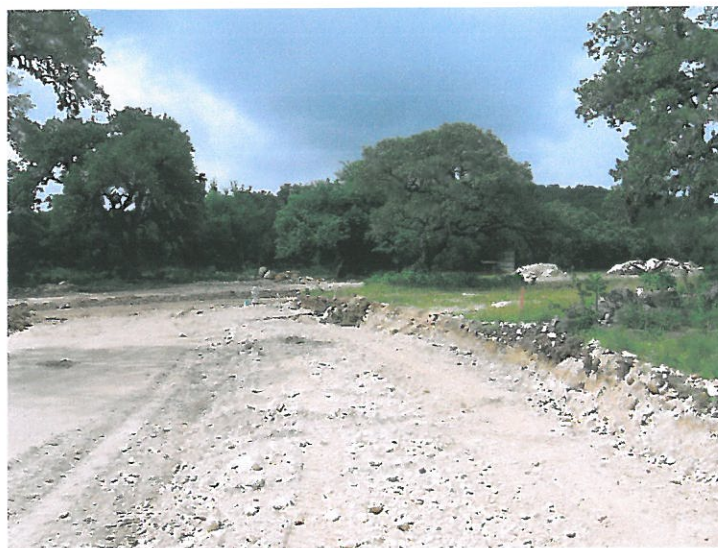
Figure 7. Road cut and conditions at Sundance #1, the former location of the historic Hausmann house.

This site was the location of a 19th century farmstead constructed about 1856 that has since been razed (Fig. 7-9). Road cuts have destroyed most of the site and all that remained at the time of the survey as an artifact scatter and a cistern (Figs 9). The GPS

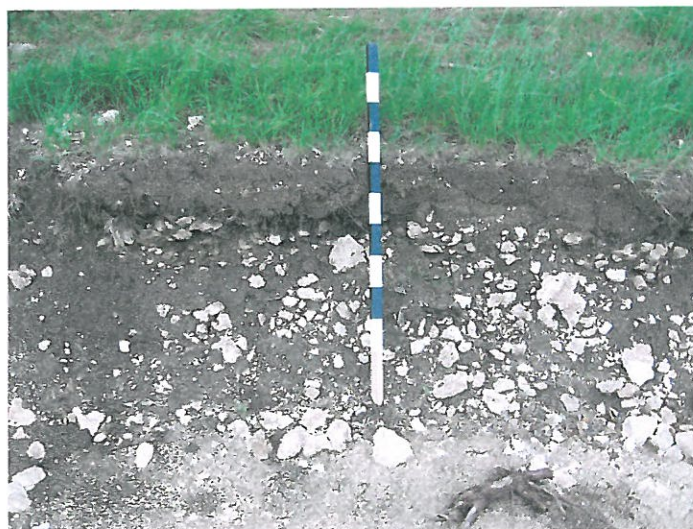
Figure 8. Road cut at Sundance #1 showing the typical profile of Brackett-Tarrant soils. Historic trash is buried just beneath the grass.

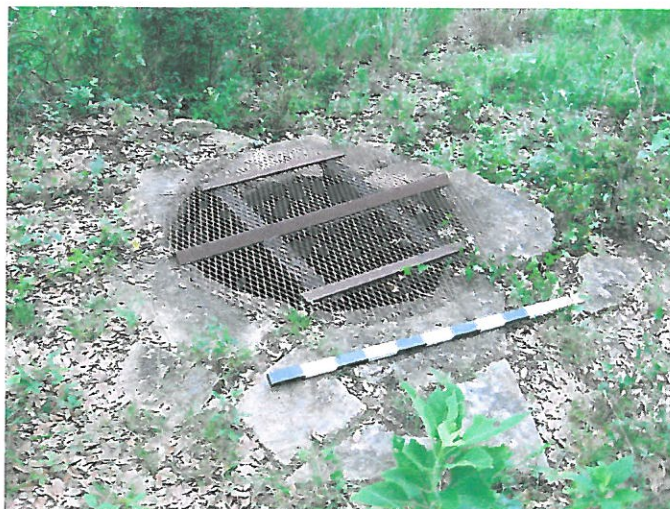
location for the cistern is 0529274E/3282893N. The house site area covered an area of about 100 meters north-south and 50 meters east-west. It is associated with a complex of historic stacked stone fences that suggest pens and pasture definition (see Fig. 13). The cistern opening was covered with a protective grate at the time of our survey (Fig. 9).

Figure 9. Cistern at Sundance #1, historic Hausmann homestead site.

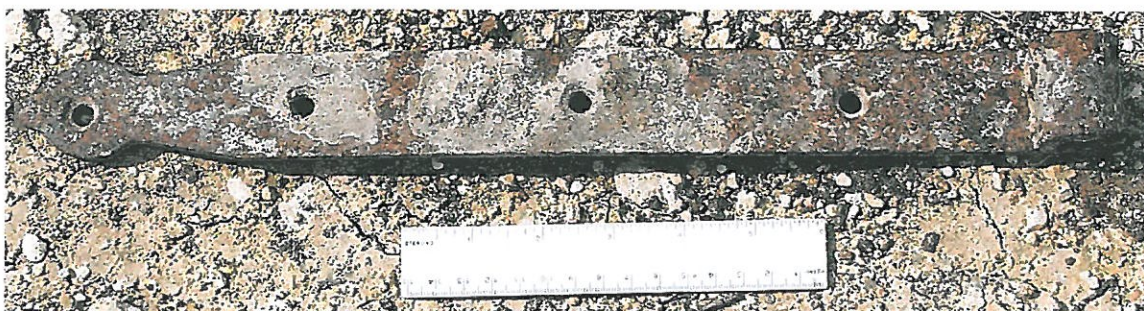
1 wrought iron hinge strap (Fig. 10).

Figure 10. Wrought iron strap hinge associated with the William Hausmann homestead.

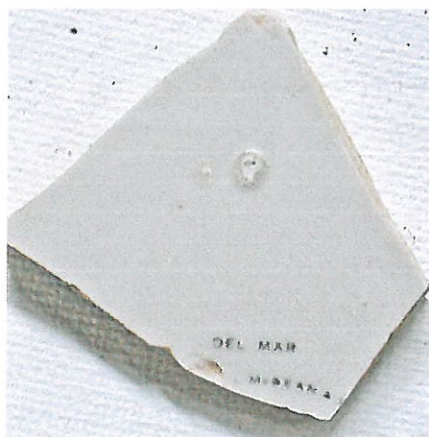
1 plate sherd of Gladden Bean Co., Franciscan Del Mar china that dates to 1957
(<http://www.hillhousewares.com/category0maker0pattern16.html>)

Figure 12. Close-up of makers mark on the Gladden McBean & Company china plate fragment.

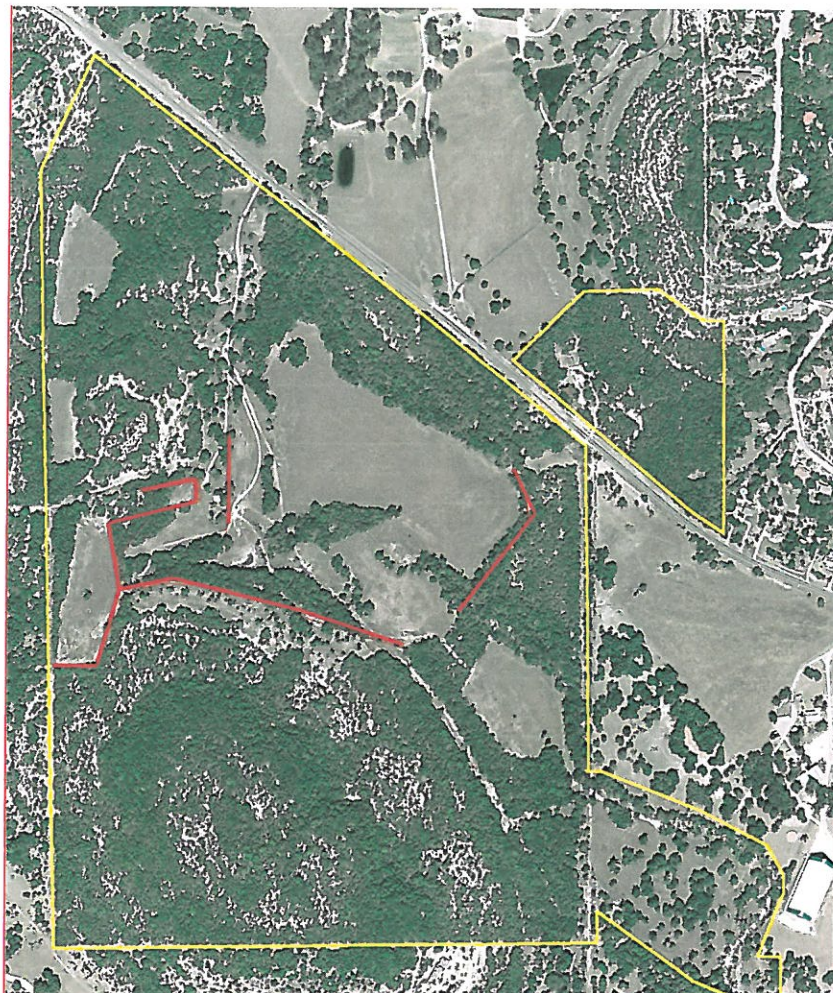
Extensive well-made rock fences are associated with the Hausmann Ranch complex. Some of these are identified in Figure 13 and shown in Figures 14-16 and 21. These fences are still substantial and are sufficiently preserved to provide barriers for livestock in places. Some segments of fence in proximity to Sundance #2 are embellished by vertical placement of fence stones as the top row of the fence (Fig. 21). While it would be desirable to preserve all of these historic fences, we recommend that at least some segments, or sections, be more precisely mapped and preserved. Those that are remarkably preserved and topped off with decorative stonework should be kept intact and integrated into landscaping for the homes. The COSA should investigate the potential of such fence sections as to their eligibility for the National Register of Historic Places. For example, have any of the stone fences of mid-19th century Bexar County been preserved during the wide scale development of the area in recent years? Knott (2004a, 2004b, 2005) has studied such fences in central Texas, especially in Blanco County.

Figure 13. Map showing rock fences at the historic Hausmann place at Sundance #1.

3. We recommend that the stone fences associated with the Hausmann-Heidemann ranch be preserved where possible and that fence segments be landscaped into house lots. Stones removed from fences should be

salvaged and incorporated into new stone structures associated with the Sundance Development.

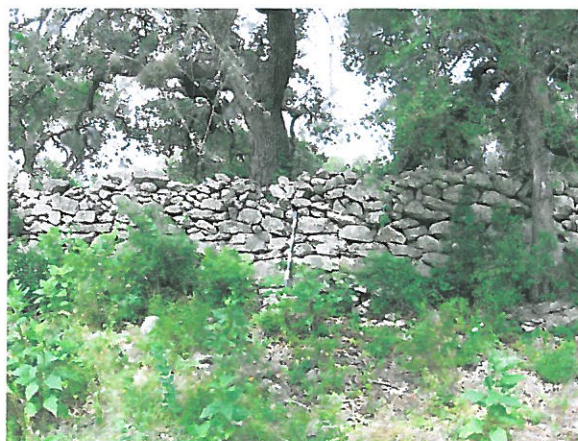
Figure 14. Part of rock fence east of the historic Hausmann house at Sundance #1.

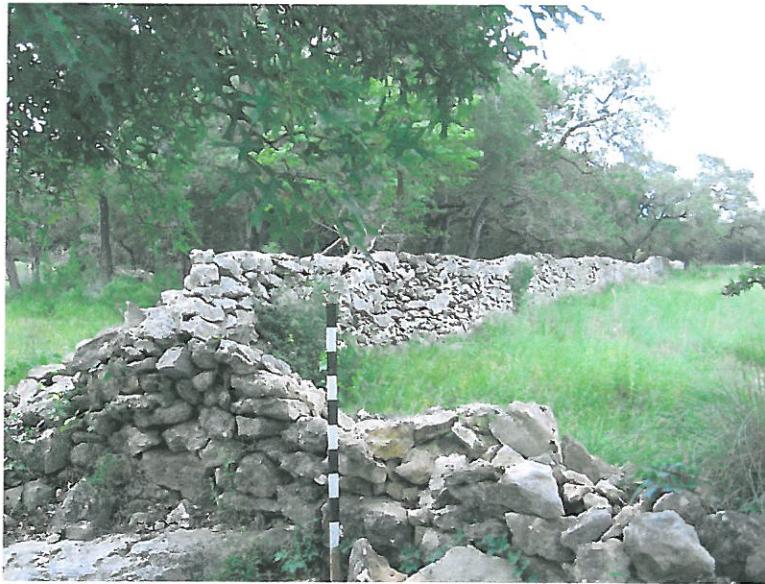
Figure 15. Rock fences west of Sundance sites #1 and 2.

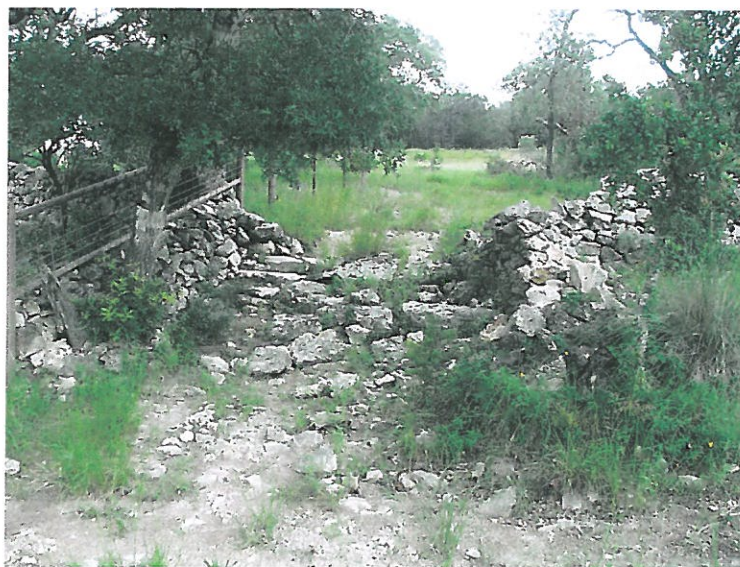
Figure 16. Gate in rock fences west of Sundance #1 and 2. This complex of rock fences is very well preserved.

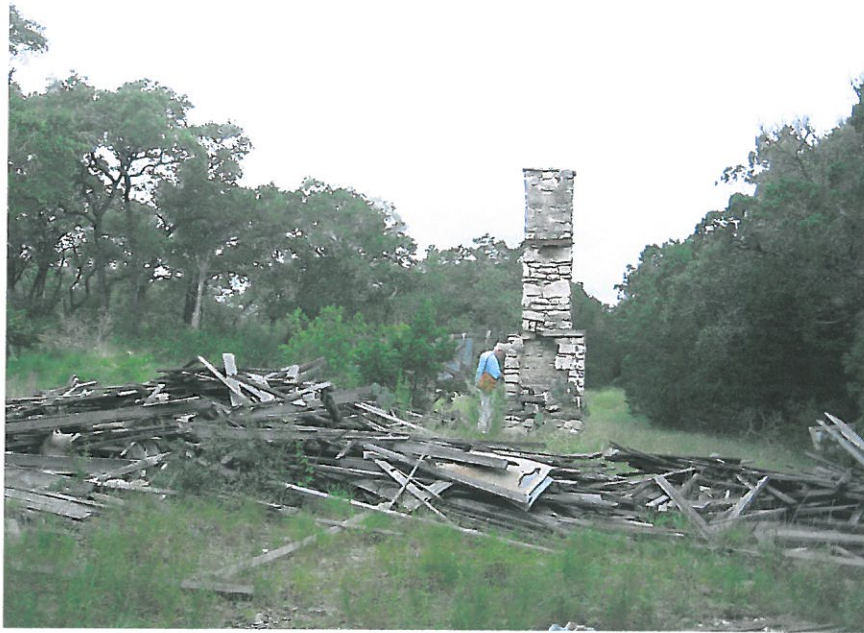
This is another historic house site. It consists of a standing rock chimney a razed board and batten house (Fig. 17, 18), and a partly standing shed. No details are available for the house. All nails were round suggesting the structure dates after 1892, or at least not earlier than about the turn of the 20th century. The GPS location for the house is 0529409E/3282785N. The artifact scatter around the house was meager and yielded no historic items that could be dated with precision. Tin cans and window glass sherds dominated the observed assemblage. The edge of an adjacent small drainage had been carefully terraced with native stone on the east side of the house. (Fig. 19). Also, there was a loose enclosure of stone, perhaps a religious shrine (Fig. 20) northeast of the house. The top of the stacked stone fence that partly defines the house grounds was also embellished with vertically stacked stones (Fig. 21). The stone chimney appears to date well before the construction of the board and batten, which likely replaced an earlier wood or stone house.

Figure 17. View from the east of the stone chimney and razed house structure at Sundance #2.

This may be the house of William Heidemann, a ranch partner to William Hausmann. The locale should be fully documented, with measurements of the fireplace and chimney. As the only remaining historic structure on the development, it may be eligible for the National Register of Historic Places if it is associated with any of the families noted above.

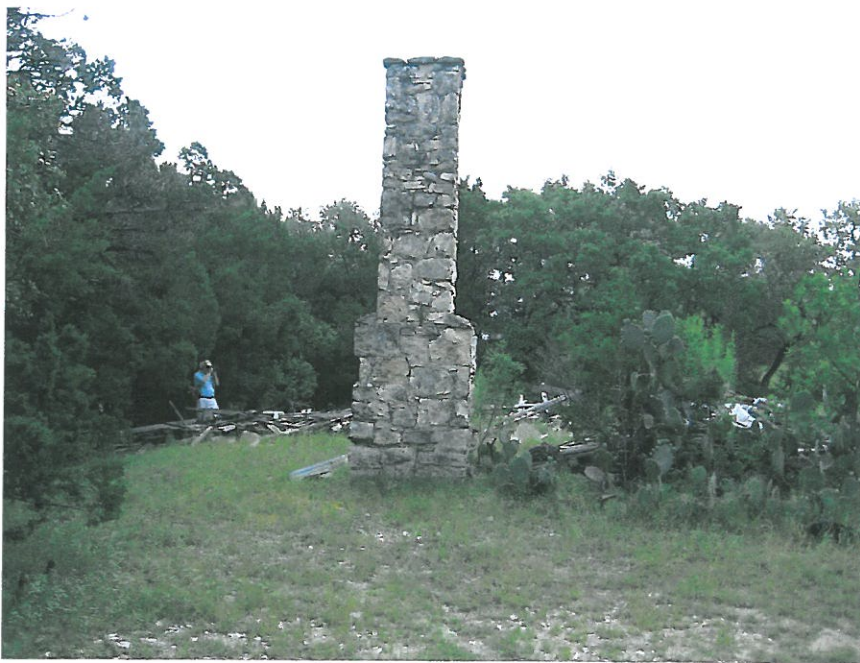
Figure 18. View of stone chimney from the west at Sundance #2

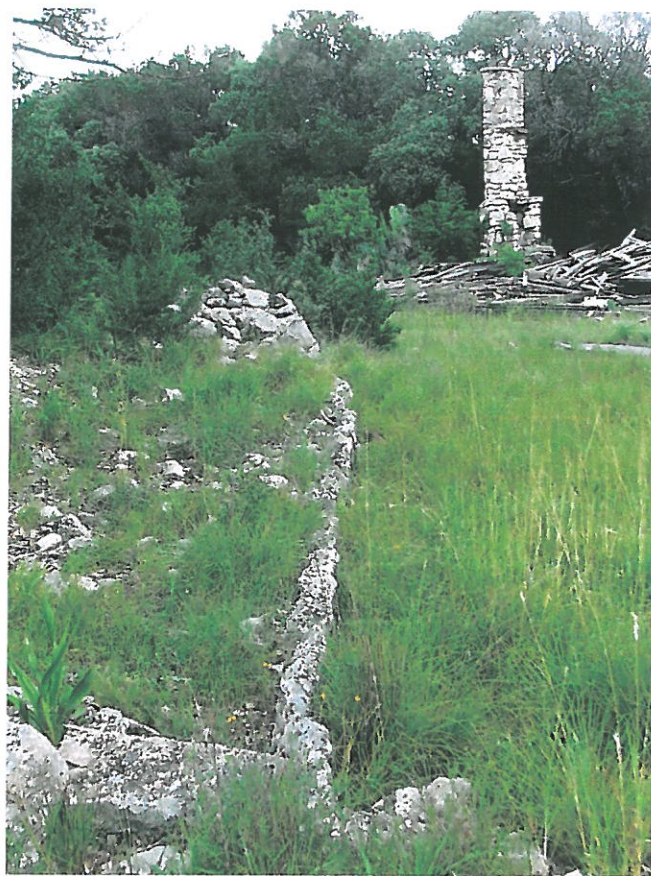
Figure 19. Stone terrace feature at Sundance #2.

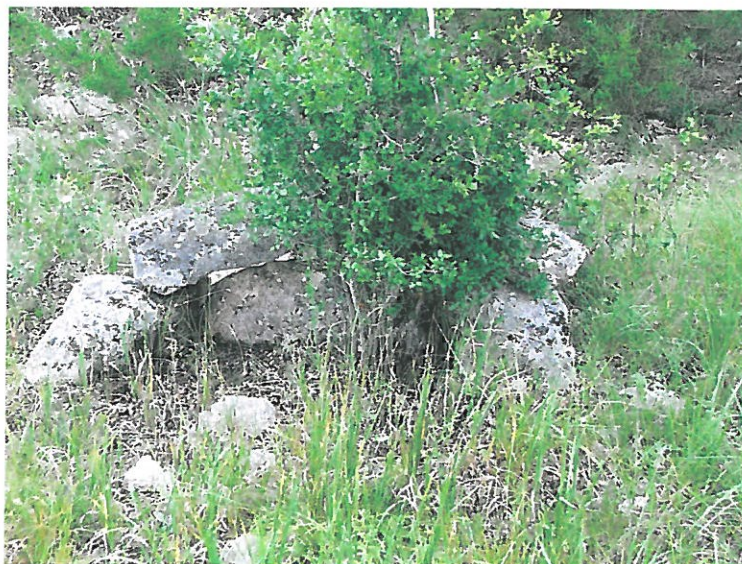
Figure 20. Stone feature at Sundance #2.

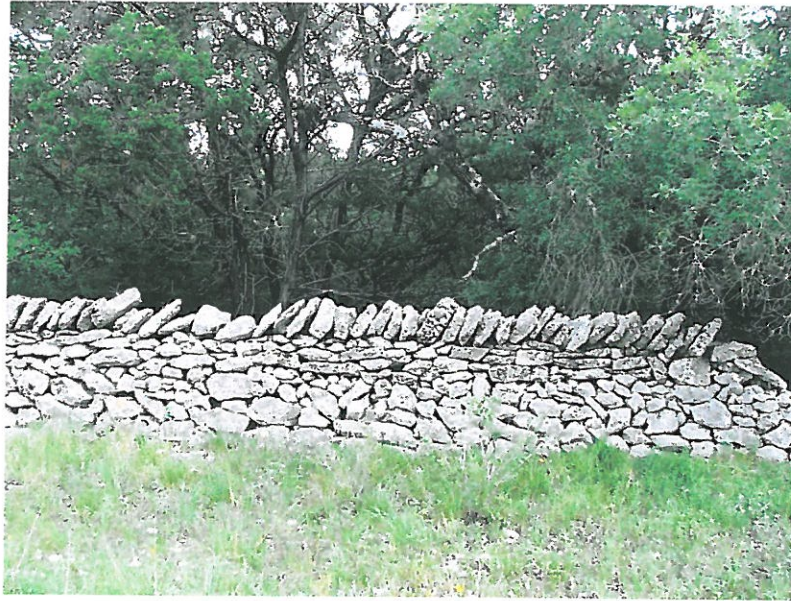
Figure 21. Embellished stacked rock fence at Sundance #2.

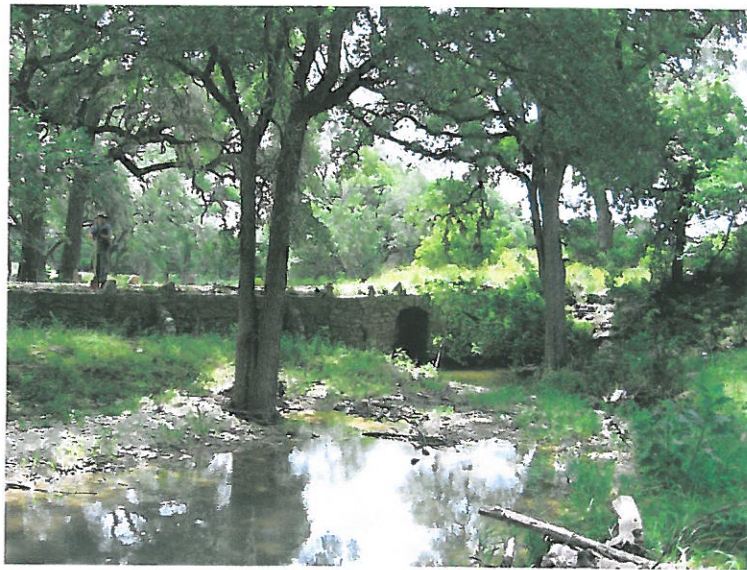
This historic structure is a narrow, one-lane bridge constructed over Pecan Creek (Figs. 22-24). The bridge is about 88 feet long, 16 feet wide, and stands about 10 feet high at the center of the creek. The GPS location is 0529707E/3283012N. The bridge is part of

an abandoned road that once led to two ranches to the south. What is interesting about the bridge is the architecture. Two masonry arches provide water passage and the bridge is embellished with a series of pointed rocks lining each side. The stones are native limestone and the mortar is Portland cement.

Figure 22. Stone bridge across Pecan Creek at Sundance #3

It is our recommendation that the bridge be preserved and restored. Recent flooding over the bridge has damaged the bridge slightly by removing some of the stones along the side, and creating a deep erosion gully on the south side near the north end. The gully needs to be filled in to stabilize the bridge and some additional masonry work will be needed to further stabilize the structure and to repair the flood damage.

4. Sundance #3 is a small stone bridge over Pecan Creek that should be preserved and stabilized. Historical research should be undertaken to determine the age of the bridge, which appears to have been on an old north-south road connecting two ranches in the area.

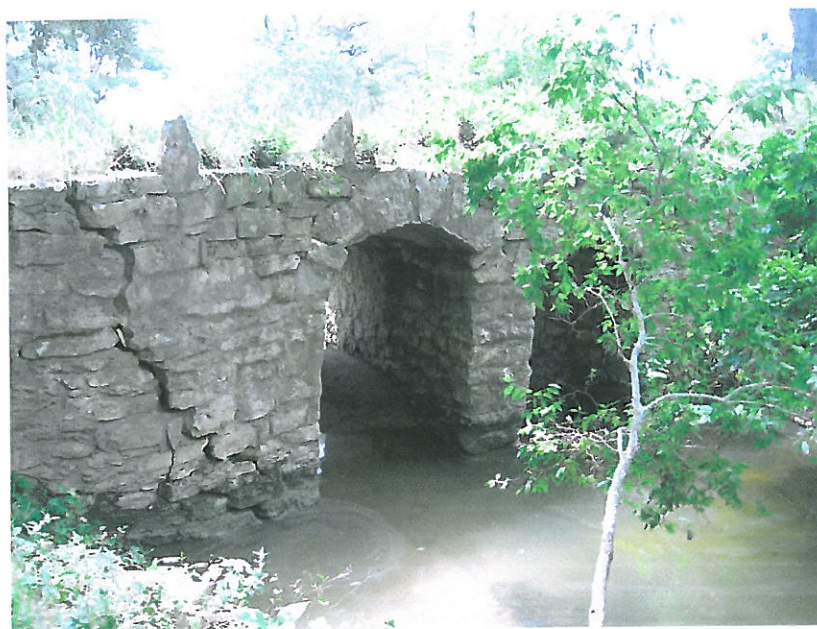
Figure 23. North side of the stone bridge at Sundance #3.

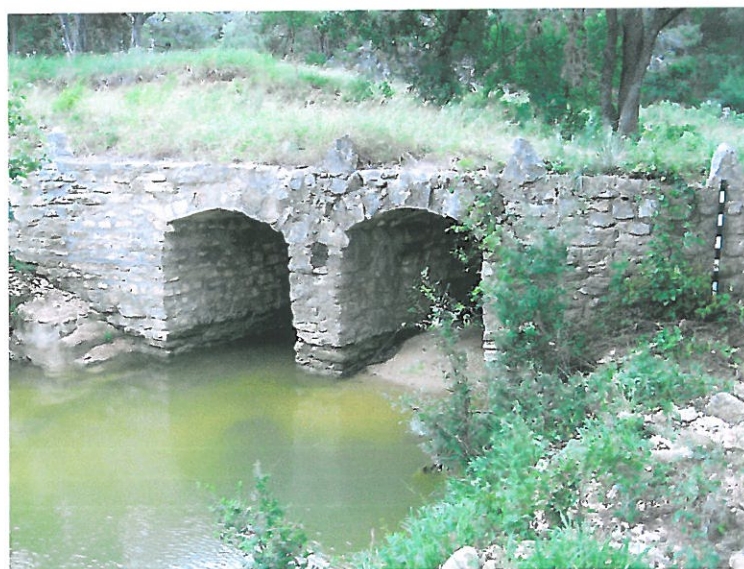
A nicely constructed stairway extends from the south end on the east side down to the water, perhaps to provide access for radiator water. While the architecture mimics the Espada Acequia bridge in San Antonio (Fig. 25), it was clearly constructed much later, probably about the 1920s or 30s, or during the time when small automobiles such as the Model A and Model T Fords were in use. There is lettering on the west side in the mid point of the bridge, but we have yet to make sense of it (Fig. 26). The lettering may refer to the date the bridge was constructed. Further investigations may be useful in providing a clearer perspective of the lettering.

Figure 24. View of the south side of the bridge with scale at Sundance #3.

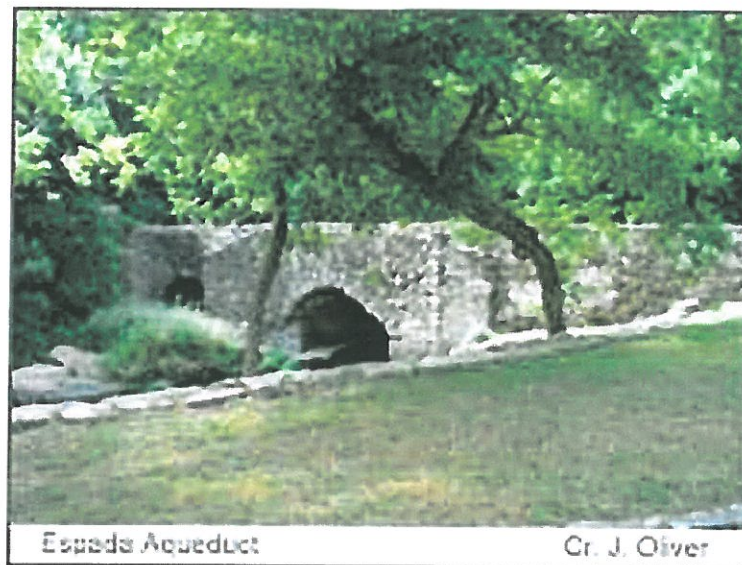
Figure 25. The Espada Acquia, San Antonio
 (<http://tps.cr.nps.gov/nhl/detail.cfm?ResourceId=618&ResourceType=Structure>)

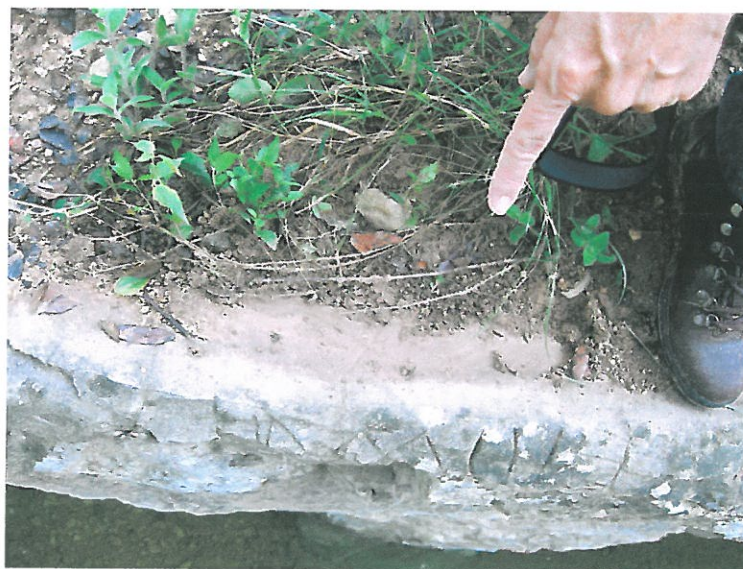
Figure 26. Un-deciphered lettering in the center of the north edge of the bridge at Sundance #3.

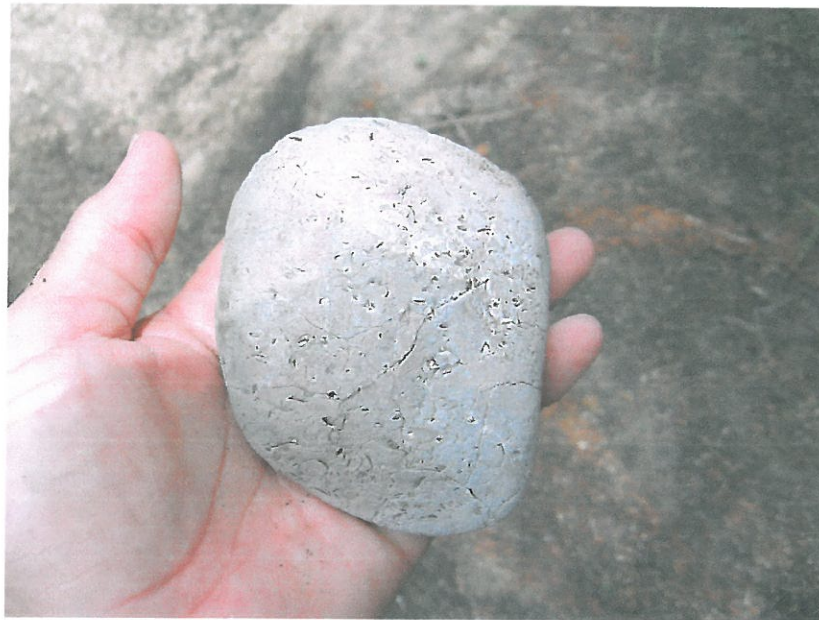
Figure 27. Possible prehistoric mano/hammerstone observed in the Lewisville association soils east of Pecan Creek.
